CLD500

Fast Response NOx Analyzer

Application Note: CLD08v01

GDI vehicle NOx breakthrough due to scavenging (blow-through)

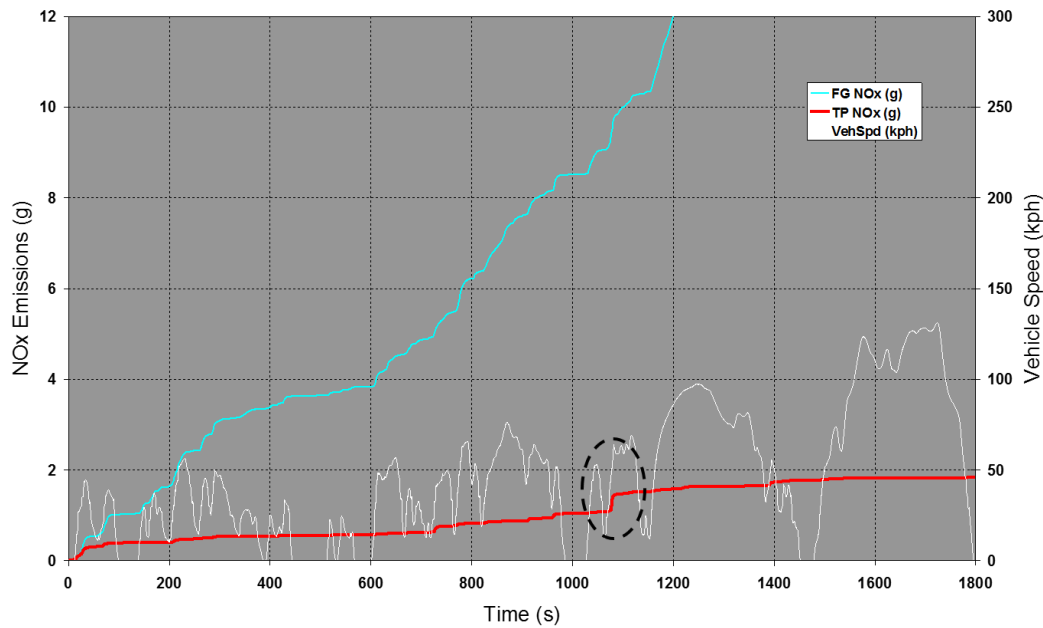
Figure 3: Tailpipe NO shows a significant increase at approximately 1080s

The cumulative tailpipe mass emissions (Figure 3) show the typical light-off characteristics of the 3-way catalyst from the cold start, but a feature of concern was the sudden rise in tailpipe NO_x at 1080s of the WLTC.

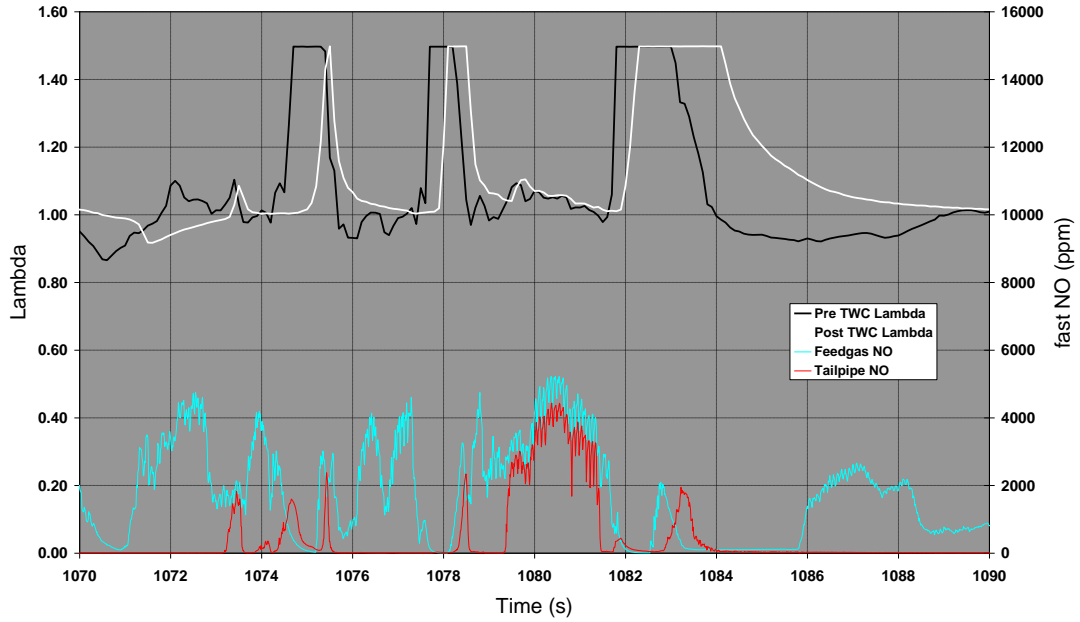
Figure 4: Fast measurement of engine-out and tailpipe [NO] during transients

The data from the CLD500 fast NO_x analyzer (Figure 4) was plotted covering this event and shows several very short duration periods of NO breakthrough to the tailpipe associated with the accelerations and gear changes from that part of the WLTC.

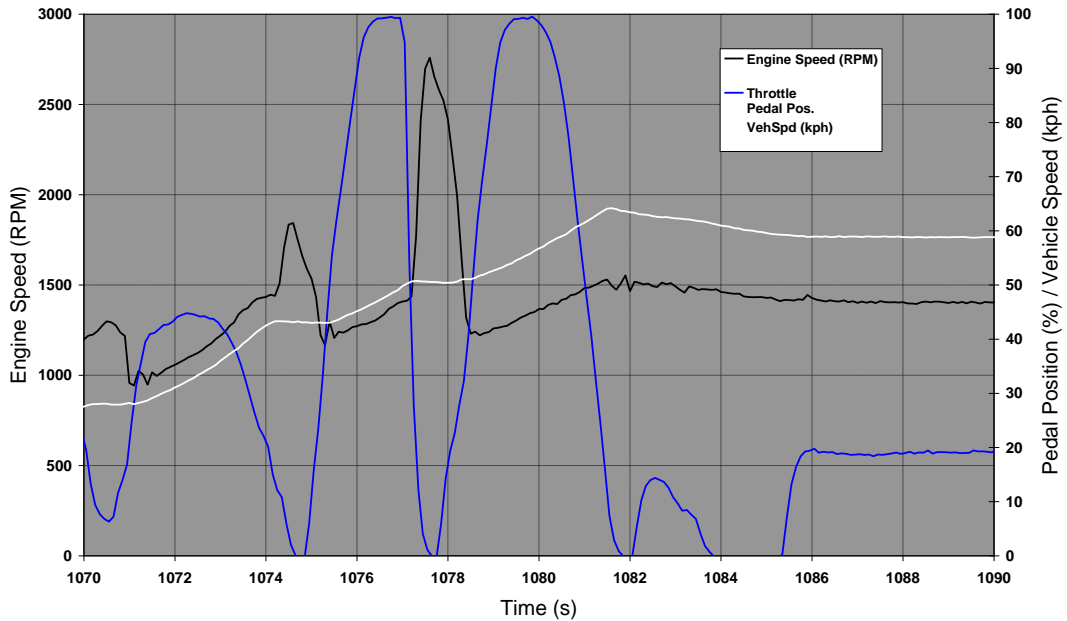
Figure 5: Indication of engine speed and load during transients

Displaying the exhaust lambda (as indicated from a wide band oxygen sensor) shows that the exhaust is lean at this time and the low engine speed and high load measured at that time (Figure 5) also suggests that blow-through is the cause of this NO_x breakthrough.
